# Manhole Inspection Summary

Manhole # S43C2\_024MH

Insp Date: **12/17/07 10:54 AM**

**Location** Address: **1101 Inner Circle**

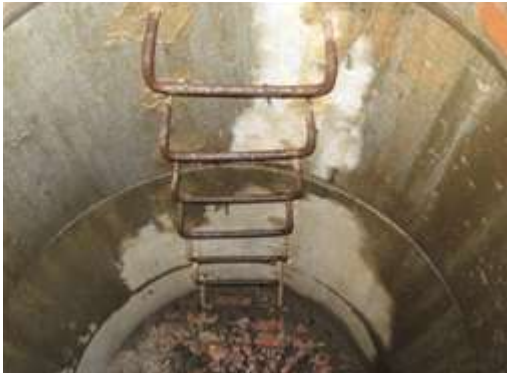
Steps

Count: **7** Missing: **0** ☐ Corroded

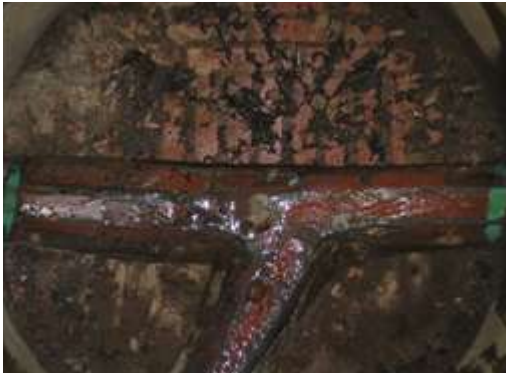
Defect 2

Debris

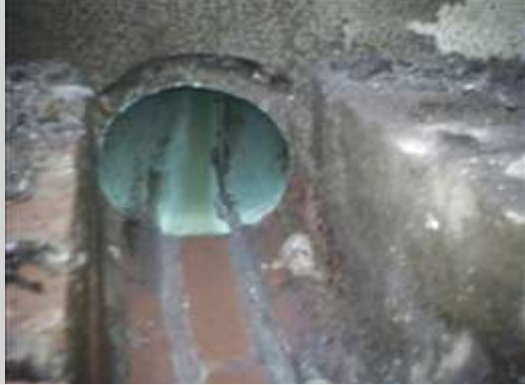
12 O'Clock Outflow

8 in. Circular Gravity Sewer  
Pipe Out @ 12 O'Clock

Pipe Height: **9.6** (in.) Rod and Bar (Angled)  
Pipe Material: **PVC** ☐ Pipe Lined  
Invert Depth: **10.24** (ft.) Flow Characteristics: **Fast**  
Deposits: ☒ None ☐ Mud ☐ Sludge ☐ Debris ☐ Grease  
Silt Depth: (in.) Deposits Extent:  
Infiltration: **None** Pipe Seal Cond: **Sound**

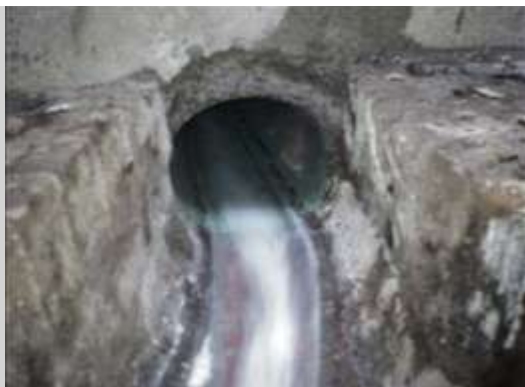
4 O'Clock Inflow

8 in. Circular Gravity Sewer  
Pipe In @ 4 O'Clock

Pipe Height: **9.6** (in.) Rod and Bar (Angled)  
Pipe Material: **PVC** ☐ Pipe Lined  
Invert Depth: **10.18** (ft.) Flow Characteristics: **Fast**  
Deposits: ☒ None ☐ Mud ☐ Sludge ☐ Debris ☐ Grease  
Silt Depth: (in.) Deposits Extent:  
Infiltration: **None** Pipe Seal Cond: **Sound**

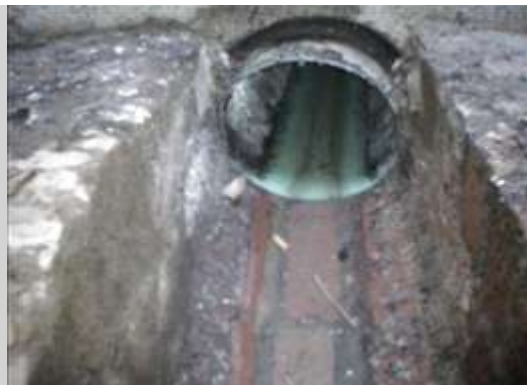
6 O'Clock Inflow

8 in. Circular Gravity Sewer  
Pipe In @ 6 O'Clock

Invert Depth: **10.11** (ft.) Flow Characteristics: **None**

Infiltration: **None** Pipe Seal Cond: **Sound**
